# U.S. SPACE & ROCKET CENTER SHUTTLE PATHFINDER REPORT 4/20/22– Draft F

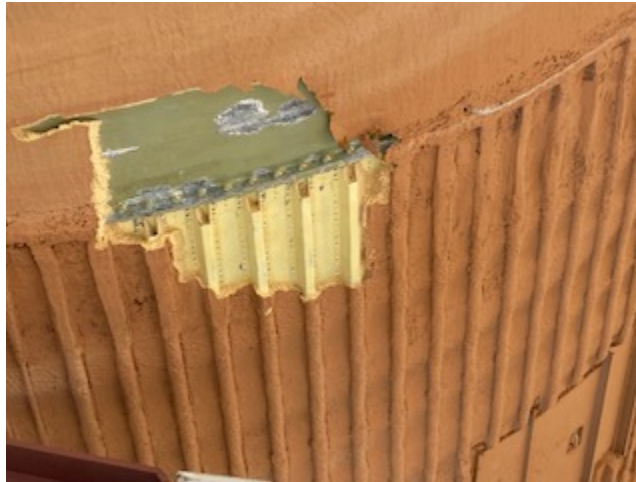
The foam on the external tank was never intended for an outdoor display. The tanks themselves were designed to disintegrate in the earth's atmosphere upon reentry. The USSRC's tank was modified slightly structurally for display as noted in the brief history above. However, it maintained the foam coating with the addition of what appeared to be a protective latex like coating. In spots the foam was showing damage especially near the top of the tank. Initial damage could have been caused by the incident where a portion of the nose from the orbiter dropped onto the tank. This damage could have also been caused and at minimum made worse by prolonged UV exposure at the top of the tank. There were also areas where bubbling was occurring on the tank. This bubbling is an indicator of delamination in areas where the foam never bonded properly to the tank on installation.

To repair, the foam will be completely removed from the tank using Sponge jet blast media. Upon removal of the foam, an inspection will be made of the tank itself for structural integrity before a new foam layer and protective coating is applied.

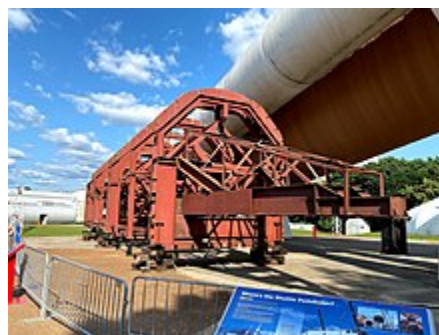
The steel Pathfinder infrastructure remains in relatively good condition. KPFF Structural Engineering has completed a full review of the steel structure. Near the rear of the frame there are areas with significant water intrusion and rusting that will need to be addressed. There are also a couple of the steel support beams that have buckled over time that will need to be repaired or replaced. KPFF has recommended methods of repair and preservation of the steel artifact. Any changes or modifications needed to the frame to support the new cover would be recommended by the structural engineers and then reviewed by the exhibit team at the USSRC and by NASA to ensure the proper care of the artifact.

An initial rough estimate for repairs for the frame is \$500,000.
